Dam ID: HI-0014
Okinawa Reservoir

Inspection No: _____
Date: 03/20/2006

STATE OF HAWAII - DLNR
VISUAL DAM SAFETY INSPECTION SHEET

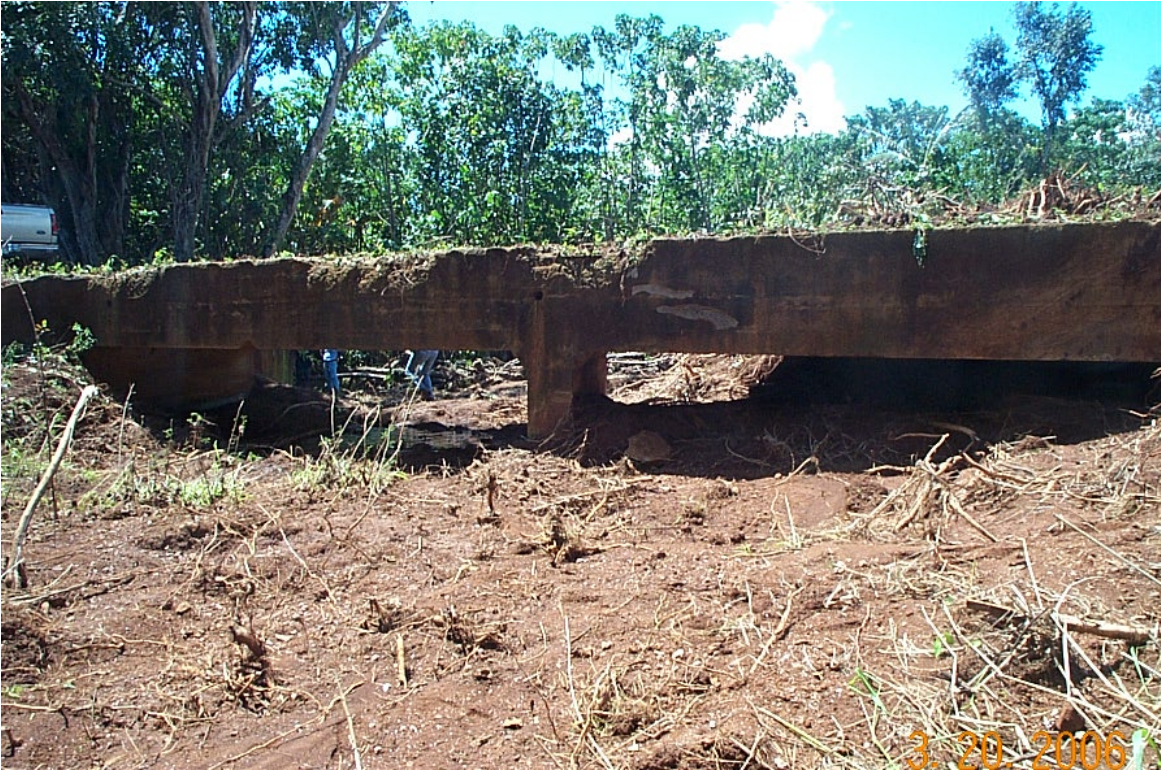
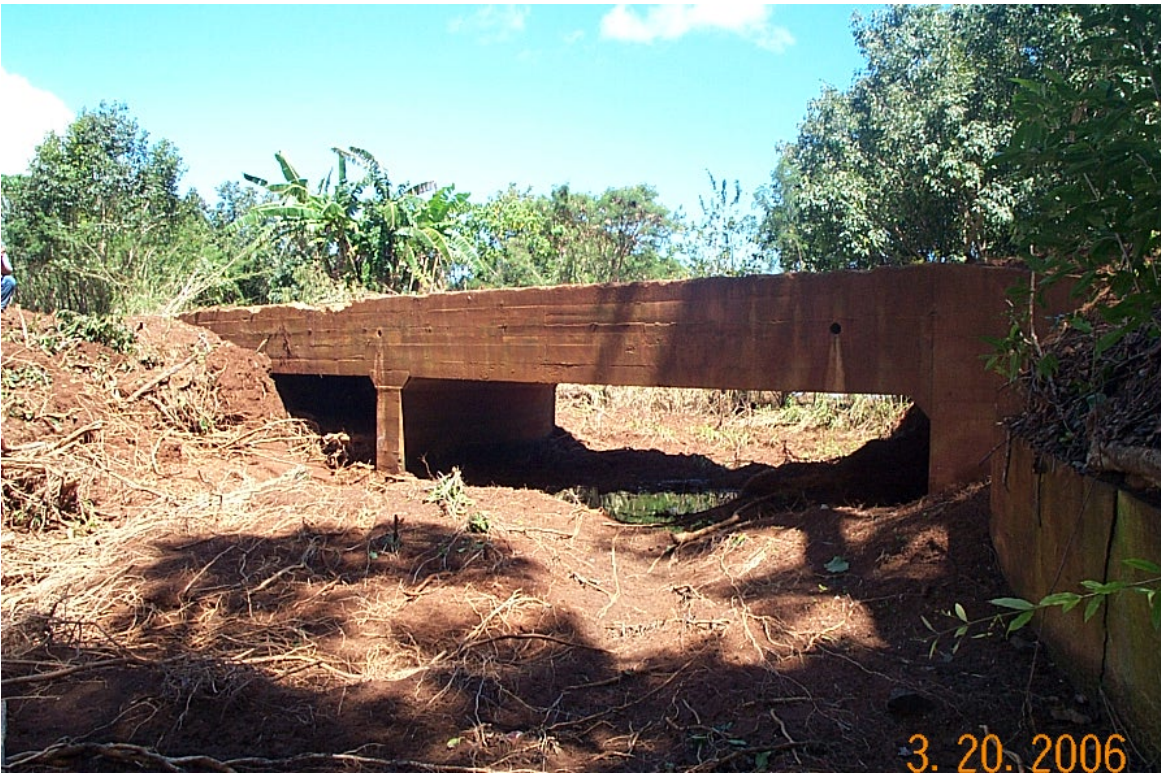
Approach: ☐ Clear ☒ High Veg. ☒ Trees ☒ Other: Right culvert half full of dirt. Left culvert clear.

HI00014 - Okinawa Reservoir: View of blocked spillway culvert. Culvert should be cleared of sediment.

- ☐ d. Slope protection needs maintenance or repair. Description: _____
- ☒ e. The spillway approach was blocked. Clear approach. **Right box culvert blocked with soil. Clear the blokage.**
- ☐ f. Severe scour erosion was observed which requires maintenance and/or repair.
Description: _____
- ☐ g. A headcut was observed downstream of the spillway. Corrective / mitigative action is required to prevent this problem from moving upstream.
- ☒ h. Trees are unacceptable in the spillway channel and approach. Take corrective action to address the woody vegetation problem and repair the damaged area.
- ☐ i. Unclear if spillway is adequately sized. Spillway should pass the probable maximum flood. Verify spillway capacity and take corrective action as required.
- ☐ j. _____

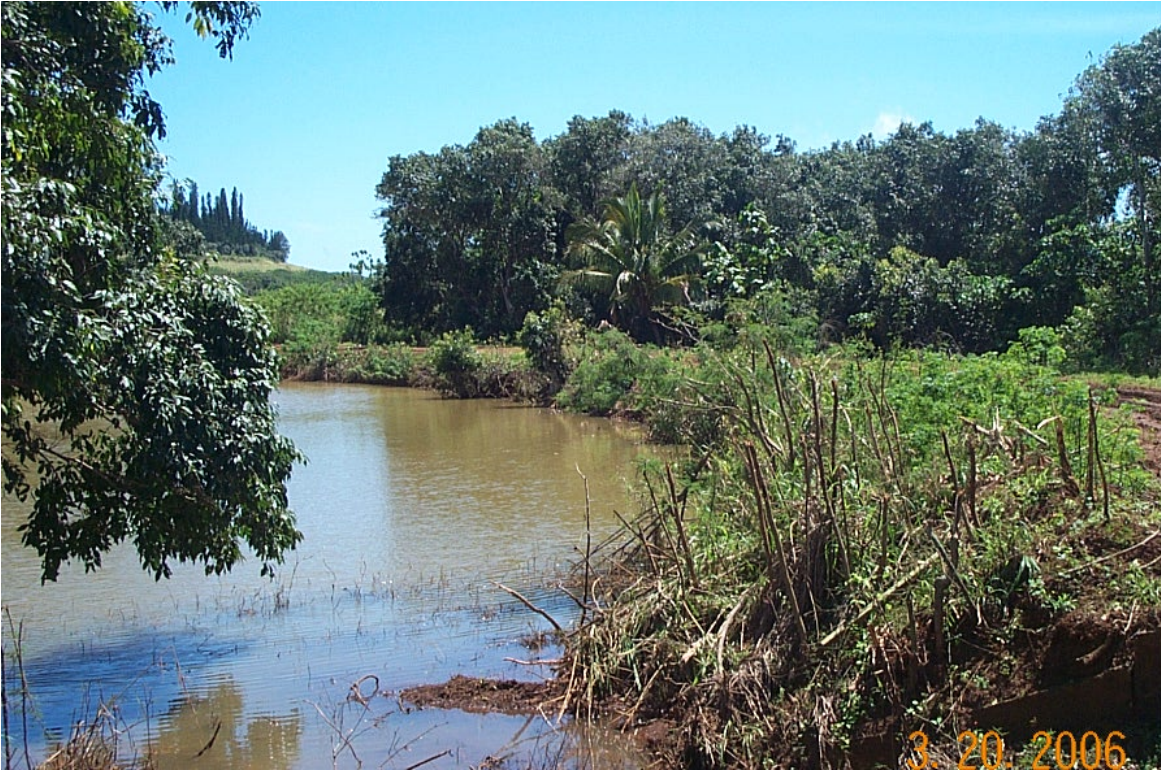
Description: Some benching observed on slope by wave action.

Description: Large trees have been cut. U/S slope relatively free of vegetation.

HI00014 - Okinawa Reservoir: View of the upstream slope of the dam.

- ☒ e. Slope protection needs maintenance or repair. Description: Monitor wave erosion. Consider placing rock slope protection.
- ☐ f. Rut and/or Gully erosion was observed on the slope, which requires maintenance and/or repair. Description: _____

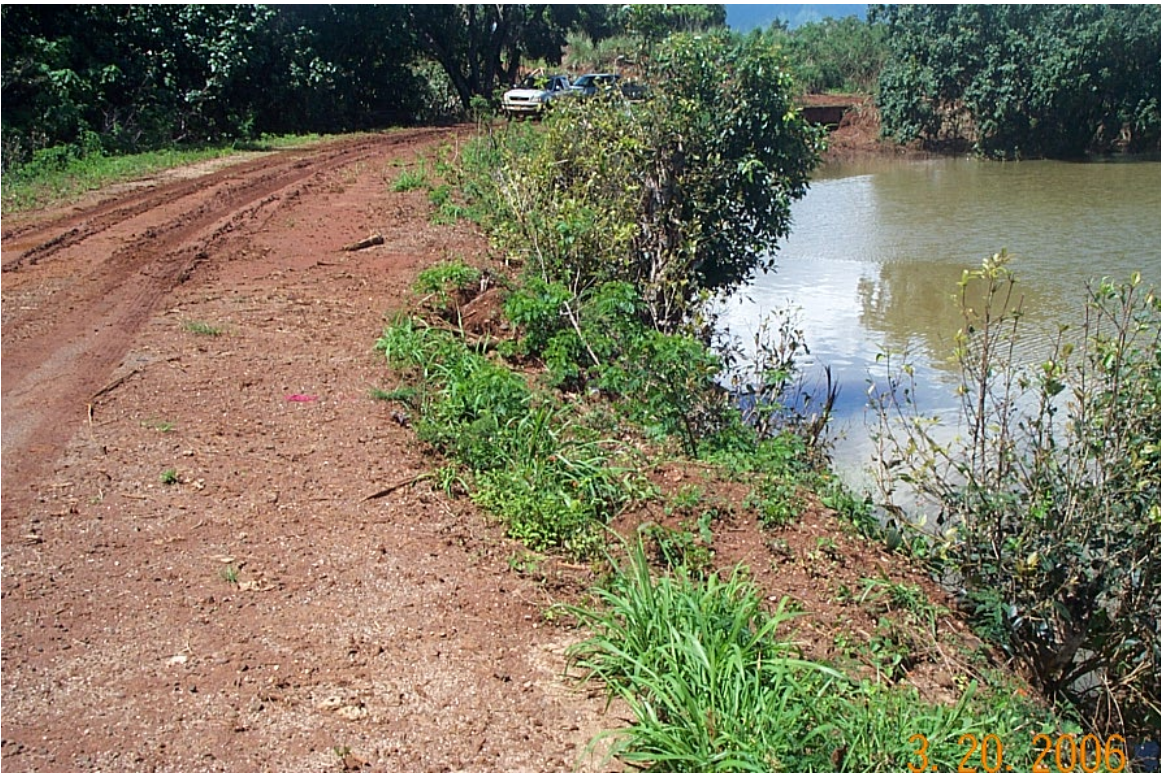
Description: Erosion on crest on u/s side in middle of dam. Caused by surface runoff on road.

HI00014 - Okinawa Reservoir: View of erosion on crest. Erosion from surface runoff flowing down the crest road.

- ☒ l. Preventive measures required in the short term to prevent surface runoff from continuing to erode the crest near the u/s hinge point.

1. Surface runoff from the right abutment currently flows down the crest and flows into the reservoir near the midpoint of the dam. The runoff has caused localized erosion and a depressed area at the location where runoff flows from the crest to the upstream slope. The condition of the embankment will continue to degrade if runoff is allowed to flow onto the crest. Surface runoff should be redirected to a place other than the crest. Runoff could be redirected into the spillway if provisions are made so that sediments do not block the box culverts. The erosion and depressed area caused by the surface runoff should be repaired.

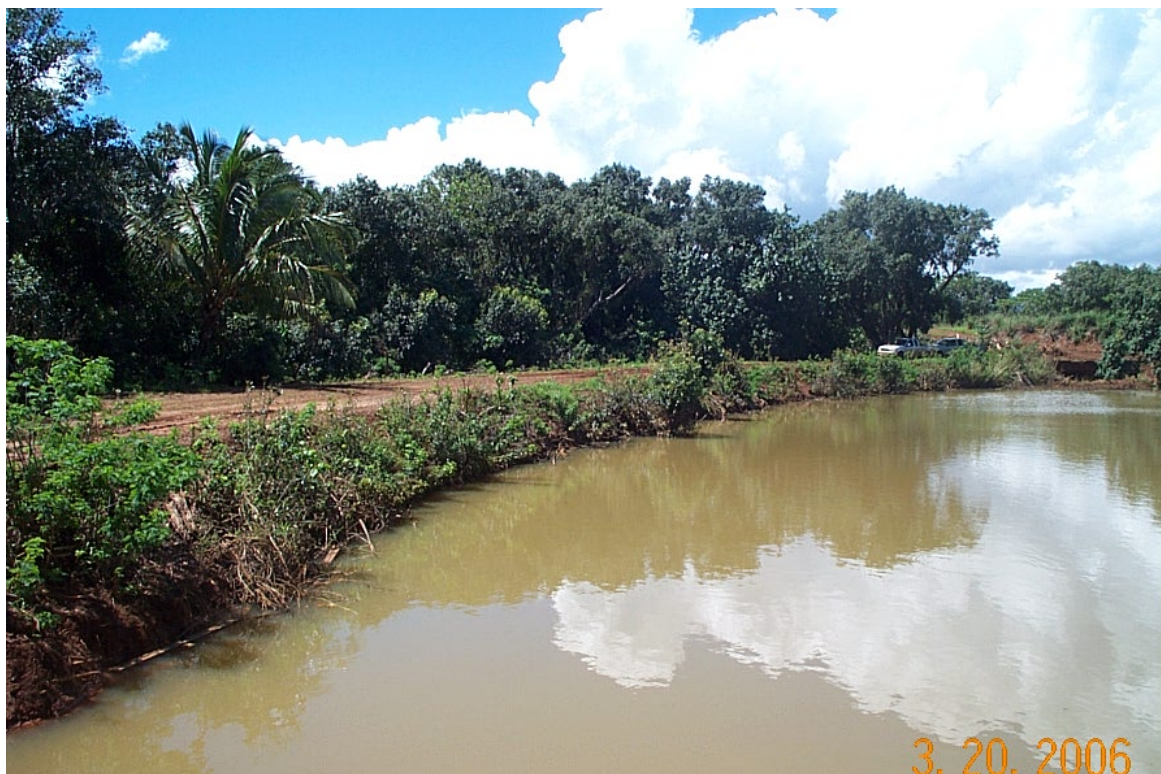
HI00014 - Okinawa Reservoir: Upstream slope.
